## Oil & Petrochemicals Case Study

# FINDING CAUSE OF WATER CONTAMINATION IN INDUSTRIAL GEARBOXES

Oil Analysis program saves chemical plant from costly failure.

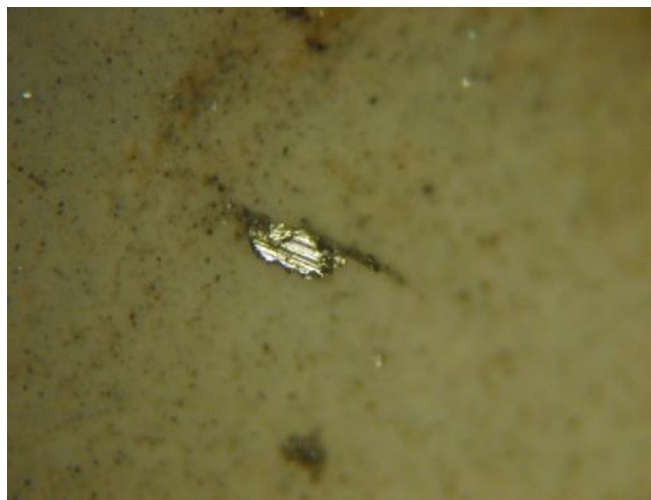
A MicroPatch test was performed to determine the source of the water ingress by identifying any unusual wear occurring or the presence of debris or contamination. An examination of the debris present did reveal that a degree of abnormal wear was occurring although there were no visual indications of any possible sources of water.

150 micron ferrous fatigue chunk

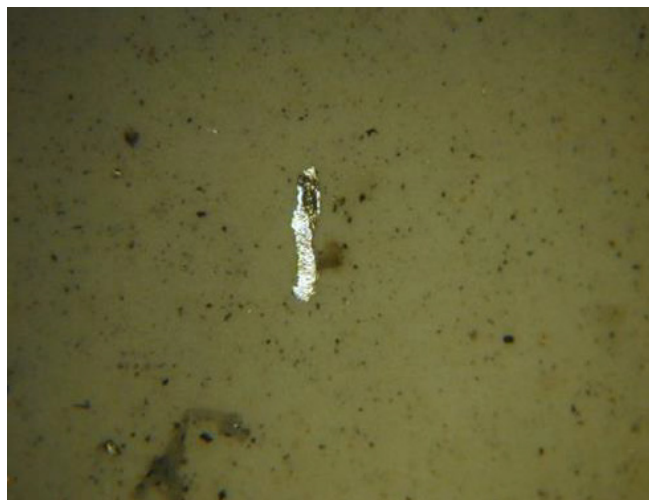
160 micron ferrous sliding wear particle
