Transformer failures within Southern Africa

by L Moodley, K Govender and Y Chinaboo, Doble Engineering Africa

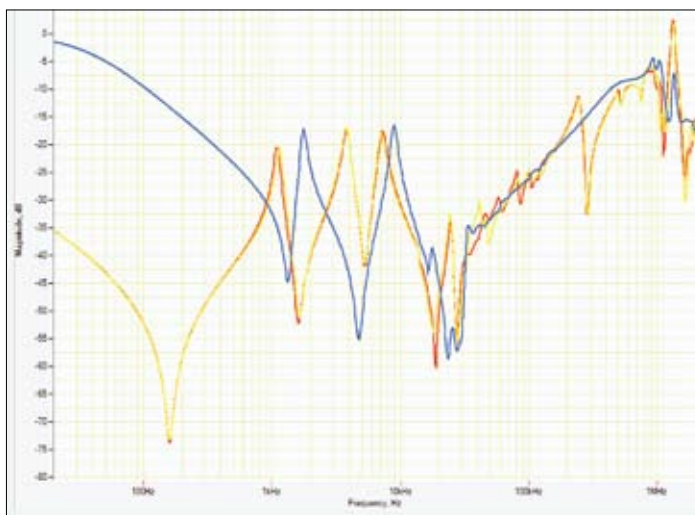
Fig. 1: HV to MV winding response.

- **SFRA tests:** The SFRA results are given in Fig. 1. The HV to MV winding open circuit test shows a significant difference in the blue phase compared to the other two phases. This is a result of a possible shorted turn, which has the effect of creating an imbalance in the reluctance on one of the core limbs, producing this characteristic change in low frequency response. Excitation current and ratio tests supported this diagnosis. However, there is also a variance on the blue phase when compared to the other phases in the mid-to-high frequency range, which indicates winding deformation. This variance warranted an internal inspection.

All the electrical tests pointed to a problem possibly limited to the tap-changer. However, the SFRA indicated clear winding/lead deformation on the blue phase. This was the result for the main tank pressure operating.

It was clear that the tap-changer had faulted. If the fault was restricted to the tap-changer, repairs would have been undertaken on site. This could have surely resulted in a further failure as a result of the tap-changer lead movement and damage to the windings as indicated by the SFRA. The transformer is due to be de-tanked and inspected in the factory.

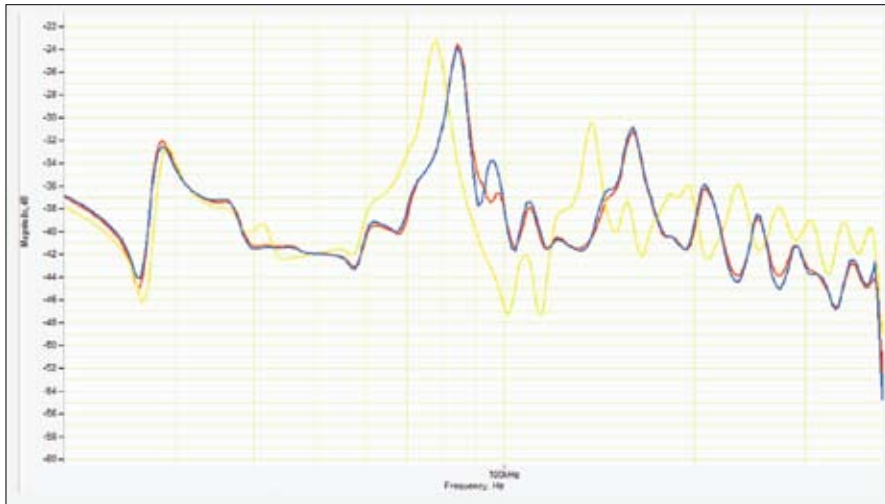
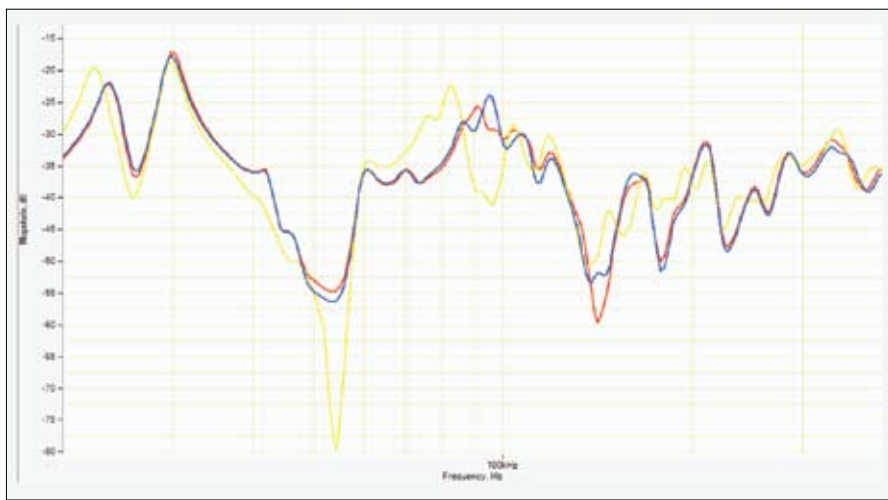
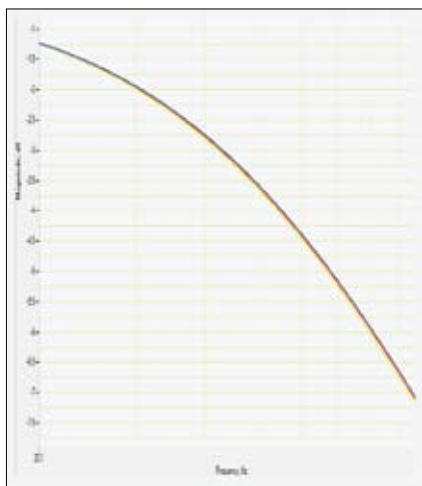
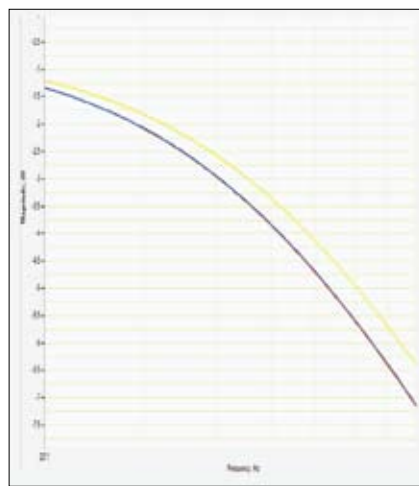
Fig. 4: HV to MV winding response.

Fig. 5: MV winding to neutral response.

Fig. 6: HV Short circuit response.

Fig. 7: MV Short circuit response.

- **Power factor and capacitance test:** The power factor and capacitance test results were within acceptable limits.
- **Ratio test:** The ratio test results were within acceptable limits.
- **Excitation current test:** The excitation currents were within acceptable tests.
- **SFRA test:** The results are given in Figs. 4, 5, 6 and 7. The HV to MV winding open circuit response shows clear variances on the middle phase

at frequencies between 20 kHz and 400 kHz when compared to the other two phases, indicating hoop buckling. The MV winding to neutral open circuit response shows similar frequency shifts on the white phase at frequencies between 20 kHz and 400 kHz, indicating deformation in the MV windings. The HV and MV short circuit response revealed no resistance or impedance change between the phases. The MV short circuit test revealed a resistance and impedance change when compared to the other phases, a clear indication that the deformation is restricted to the MV winding.

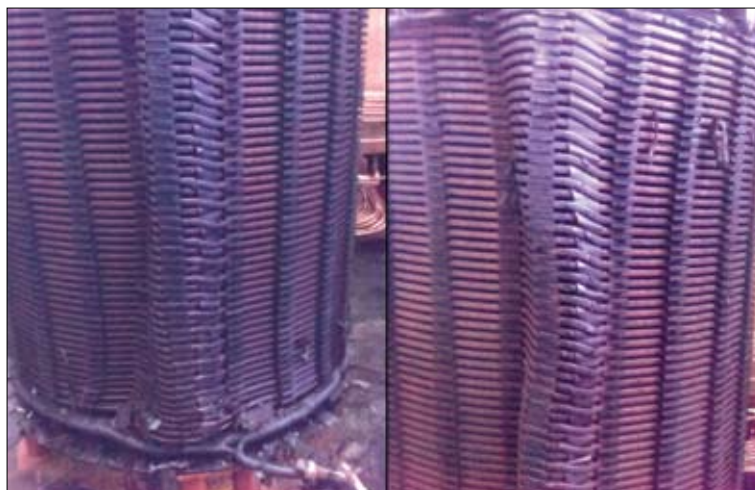
Fig. 8: MV white phase.

The transformer was internally inspected and the MV winding had clear indications of winding deformation in the form of hoop buckling. This is shown in Fig. 8. In this case SFRA proved to be the only test that could detect this type of fault as all other electrical and oil tests gave no indication.

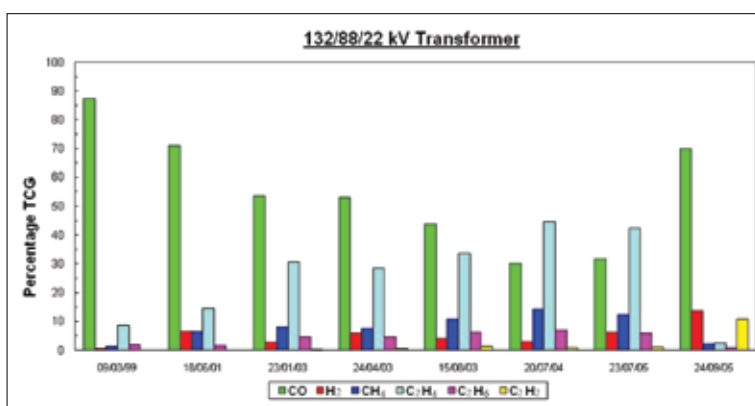
Fig. 9: DGA signatures.

The results are shown in Fig 9. The Doble Algorithm results are shown in Fig 10. From 1999 until 2005 the transformer experienced a localized thermal fault. This is signified by the high levels of ethylene and significant levels of methane and ethane. A DGA signature of this pattern indicates a core and frame to earth circulating current. The transformer experienced a dielectric fault on 24 September 2005. This is indicated by the levels of hydrogen and acetylene. The root cause of the transformer failure was the uncorrected thermal fault that was present since 1999.

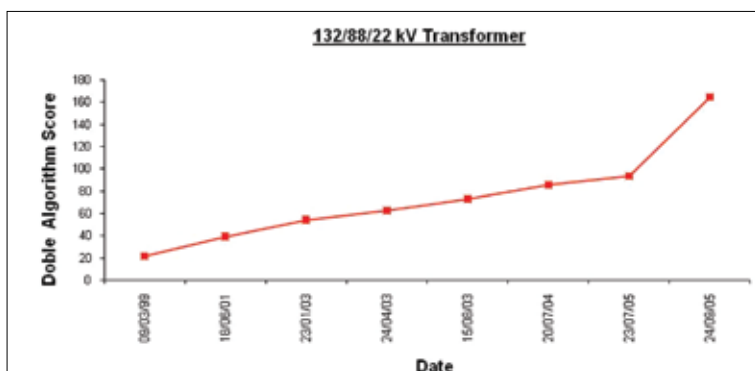
Fig. 10: Double algorithm scores.

In this case study it is clear that the Doble algorithm identified the fault many years before the failure, and also indicates a steady increase in the scoring, which indicates a worsening condition.

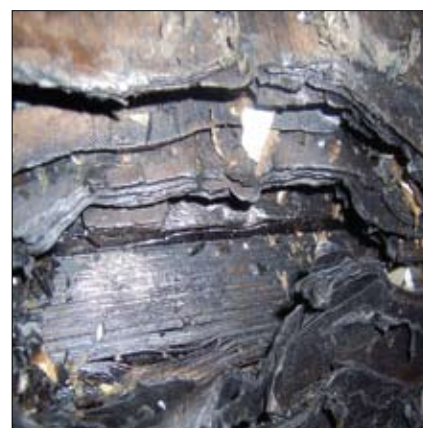
Fig. 11: Uncorrected thermal fault.

After the analysis of the DGA test results, an internal inspection was performed. The results are shown in Fig. 11.

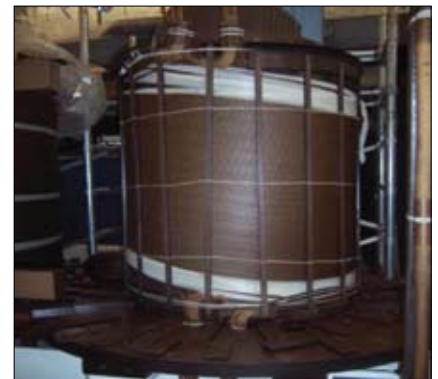
Fig. 13: Axial collapse.

A 132/11 kV transformer, manufactured in 1978, and rated at 30 MVA was taken out of service as a result of a Buchholz alarm. The DGA indicated a dielectric fault possible involving the winding. Apart from having elevated power factor results all other tests did not give a clear indication of the possible problem. The SFRA results showed a significant shift of a number of resonances for the C phase LV winding (Fig. 12). The transformer was removed from service and a tear down was performed. The internal inspection revealed an axial collapse of the C phase of the LV winding (Fig 13).
