## Oil & Petrochemicals Case Study

# FINDING CAUSE OF WATER CONTAMINATION IN INDUSTRIAL GEARBOXES

Oil Analysis program saves chemical plant from costly failure.

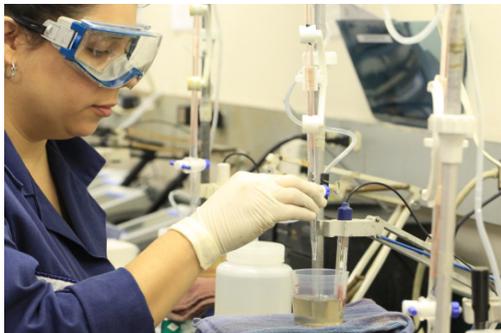
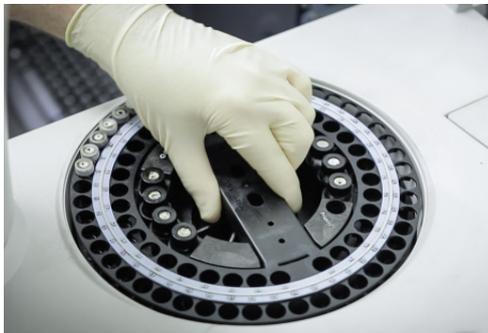
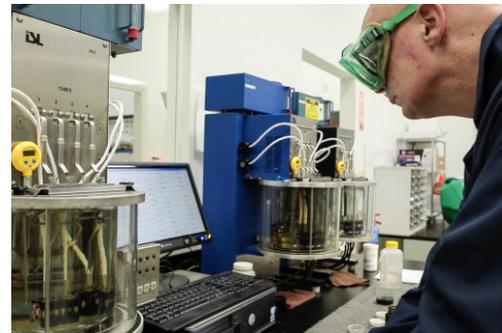
A MicroPatch test was performed to determine the source of the water ingress by identifying any unusual wear occurring or the presence of debris or contamination. An examination of the debris present did reveal that a degree of abnormal wear was occurring although there were no visual indications of any possible sources of water.
