Effective Varnish Removal from Turbine Lubrication Systems

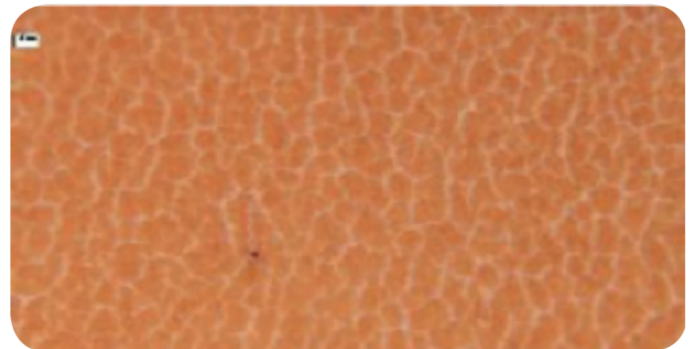
This photomicrograph shows varnish material on an analysis membrane (0.45-micron porosity) at 100x magnification.

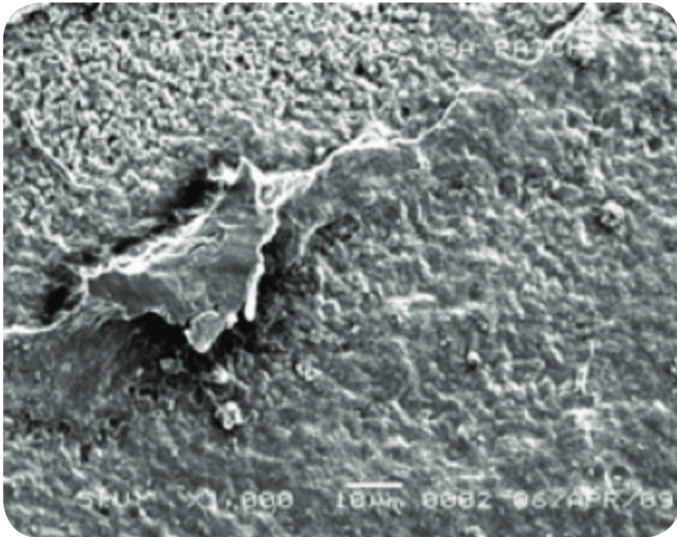
The same varnish material is shown at 1,000x magnification using a scanning electron microscope.

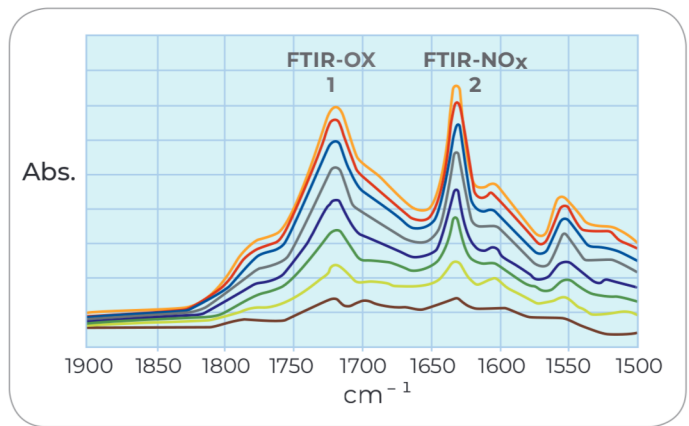
This FTIR spectra shows varnish material produced by oxidation and thermal degradation with characteristic absorbance peaks in the 1740 cm⁻¹ region.

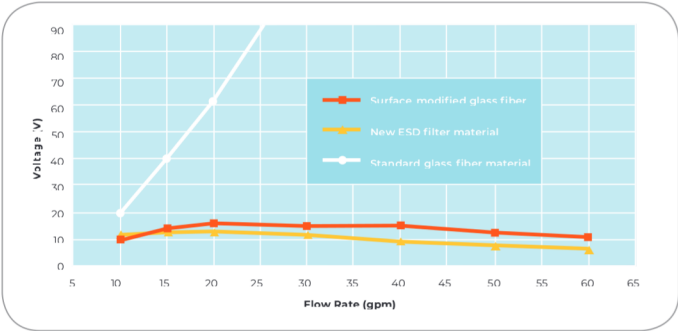
Fluid charging with standard glass-fiber and electrostatic dissipative (ESD) filter elements.

In 2004, a new series of electrostatic dissipative (ESD) filter media were introduced to eliminate potential electrostatic charging problems in filtration of hydrocarbon fluids. Extensive testing in controlled laboratory conditions and on operating equipment in many industrial applications has shown this filtration media to eliminate filter damage and significantly lower charge generation compared with the typical glass-fiber filtration medium.

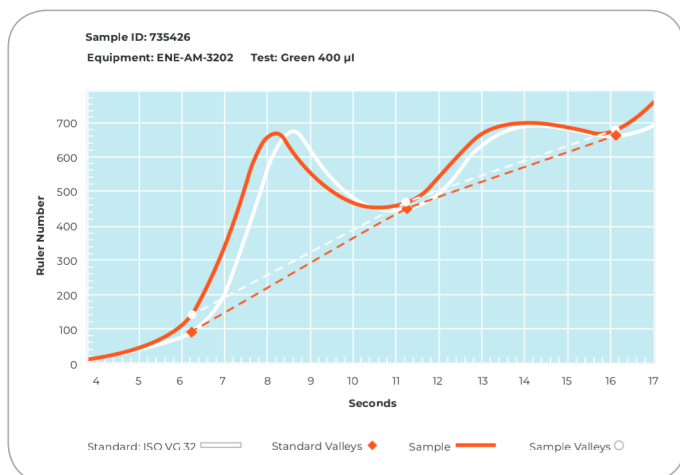
*Aromatic Amine = 99%, Hindered Phenolic >100%
Results of the analysis conducted on a new, unused fluid sample.*

Tests were also conducted to assess the effect on the fluid's additives as a result of the treatment with the VRF medium. The results indicated essentially no change in the level of aromatic amine and hindered phenol between the unfiltered sample and the sample that was filtered 20 times. The absence of any depletion of this additive suggested that the VRF medium had no noticeable adverse effect on the fluid.

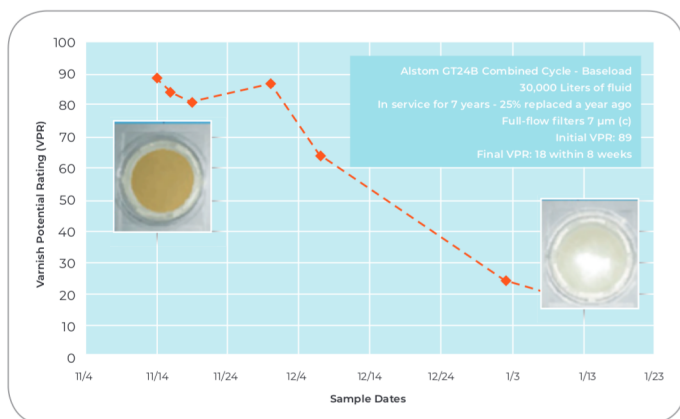
Field trial results on an Alstom turbine.

Following clean-up of the Alstom turbine, the VRF skid was removed, and the plant re-installed the electrostatic-type cleaner that had been used before the VRF treatment. A sample from the Alstom turbine was obtained about six months after the VRF treatment and was found to have elevated varnish levels. The GE Frame 7FA turbine was sampled two months after the VRF treatment and had low varnish levels similar to that at the time of the termination of the treatment.

The reason for the recurrence of the high varnish level in the Alstom turbine is believed to be the heavy varnish deposits in the system that were not completely removed during the eight weeks of the fluid treatment, although the varnish precursors in the fluid phase were reduced to very low levels. The difference in the fluid clean-up rate, which was longer in the case of the Alstom turbine, and the slight increase after the initial decrease in the varnish level can also be attributed largely to the presence of heavy varnish deposits in the Alstom turbine lubrication system.

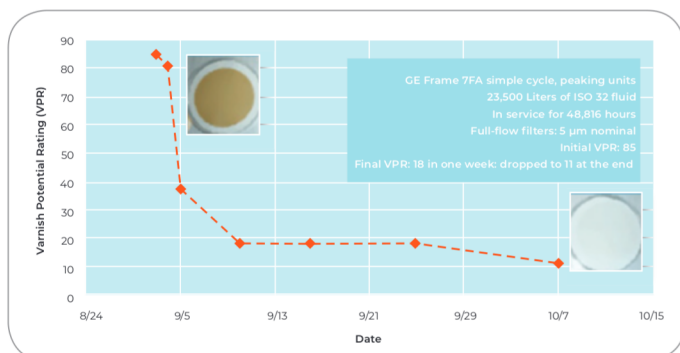
Field trial results on an GE Frame 7FA turbine.

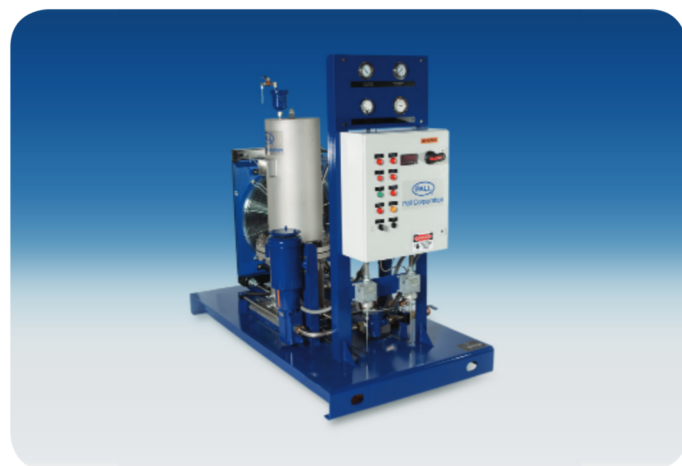
This Varnish Removal Filter skid was used to treat two operating turbines.

Following successful laboratory validation of the filtration medium, a skid incorporating the VRF filter modules and the associated control system was tested on two operating turbines. The treatment of the turbine lubrication systems entailed installation of the skid in a kidney-loop mode, taking the fluid from one end of the reservoir and returning it to the opposite end continuously. Both trials ran uninterrupted with minimal operator intervention and utilized one set of three VRF modules for each trial. The removal and retention of varnish material by the filtration medium was indicated by the staining of the medium by the varnish material.

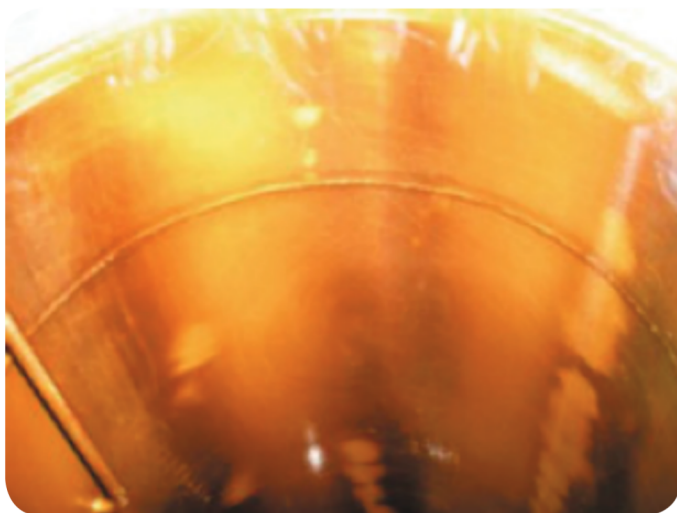
Varnish deposits were found inside the filter housing of the Alstom turbine lubrication system.

One significant difference between the two turbines treated with the VRF was the level of varnish deposits in the lubrication systems. The inside of the main flow filter housing on the Alstom turbine lubrication system indicated the presence of a heavy brownish coating of varnish material. No such deposits were observed in the GE Frame 7FA turbine lubrication system.

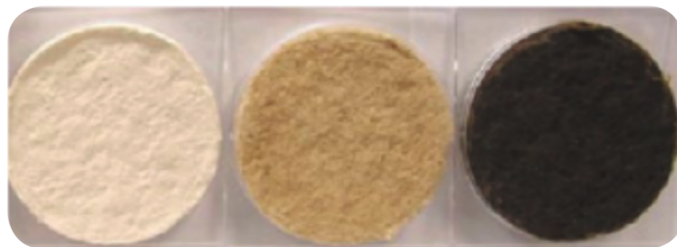
These images show a used VRF medium as received from the field (right), rinsed with hexane (center) and rinsed with toluene (left).

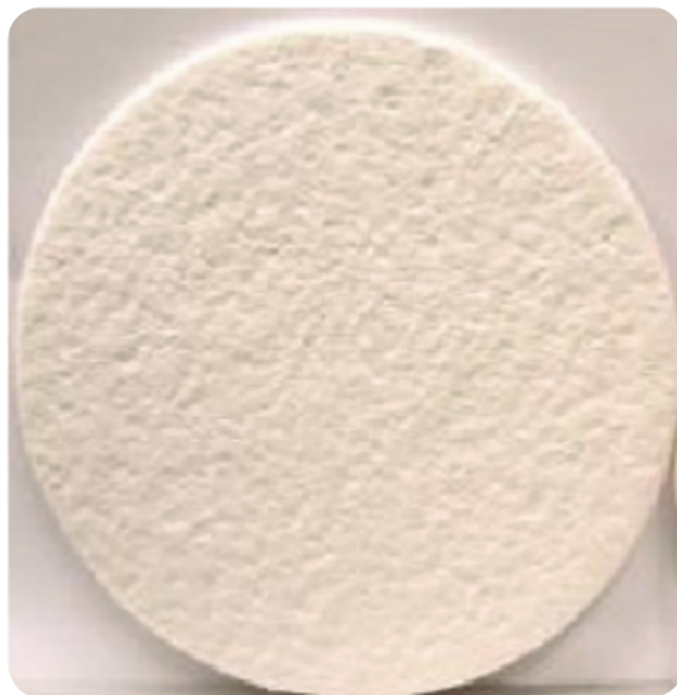
An unused VRF medium.

A filtration medium based on physisorption, called a Varnish Removal Filter (VRF), has been developed. This filtration medium is a composite consisting of a cellulose fiber matrix and other materials that give it a high-void volume and an open-fiber matrix. The resin-bonded, open-fiber matrix provides high permeability, which is necessary for the fluid to come in contact with the large fiber surface area for the absorption of the varnish precursors. The specially formulated binder resins give the filter media high affinity for the polar varnish precursors, resulting in high removal efficiency and retention of the material suspended in the fluid phase.
